NATIONAL TRANSPORTATION SAFETY BOARD
OFFICE OF AVIATION SAFETY
WASHINGTON, D.C.

SYSTEMS AND POWERPLANTS GROUP CHAIRMAN'S FACTUAL
REPORT OF INVESTIGATION

A. ACCIDENT : MIA99FA245

AIRCRAFT : Beachcraft B90 King Air, N338AS, Operated by CP
Horizons, Inc.

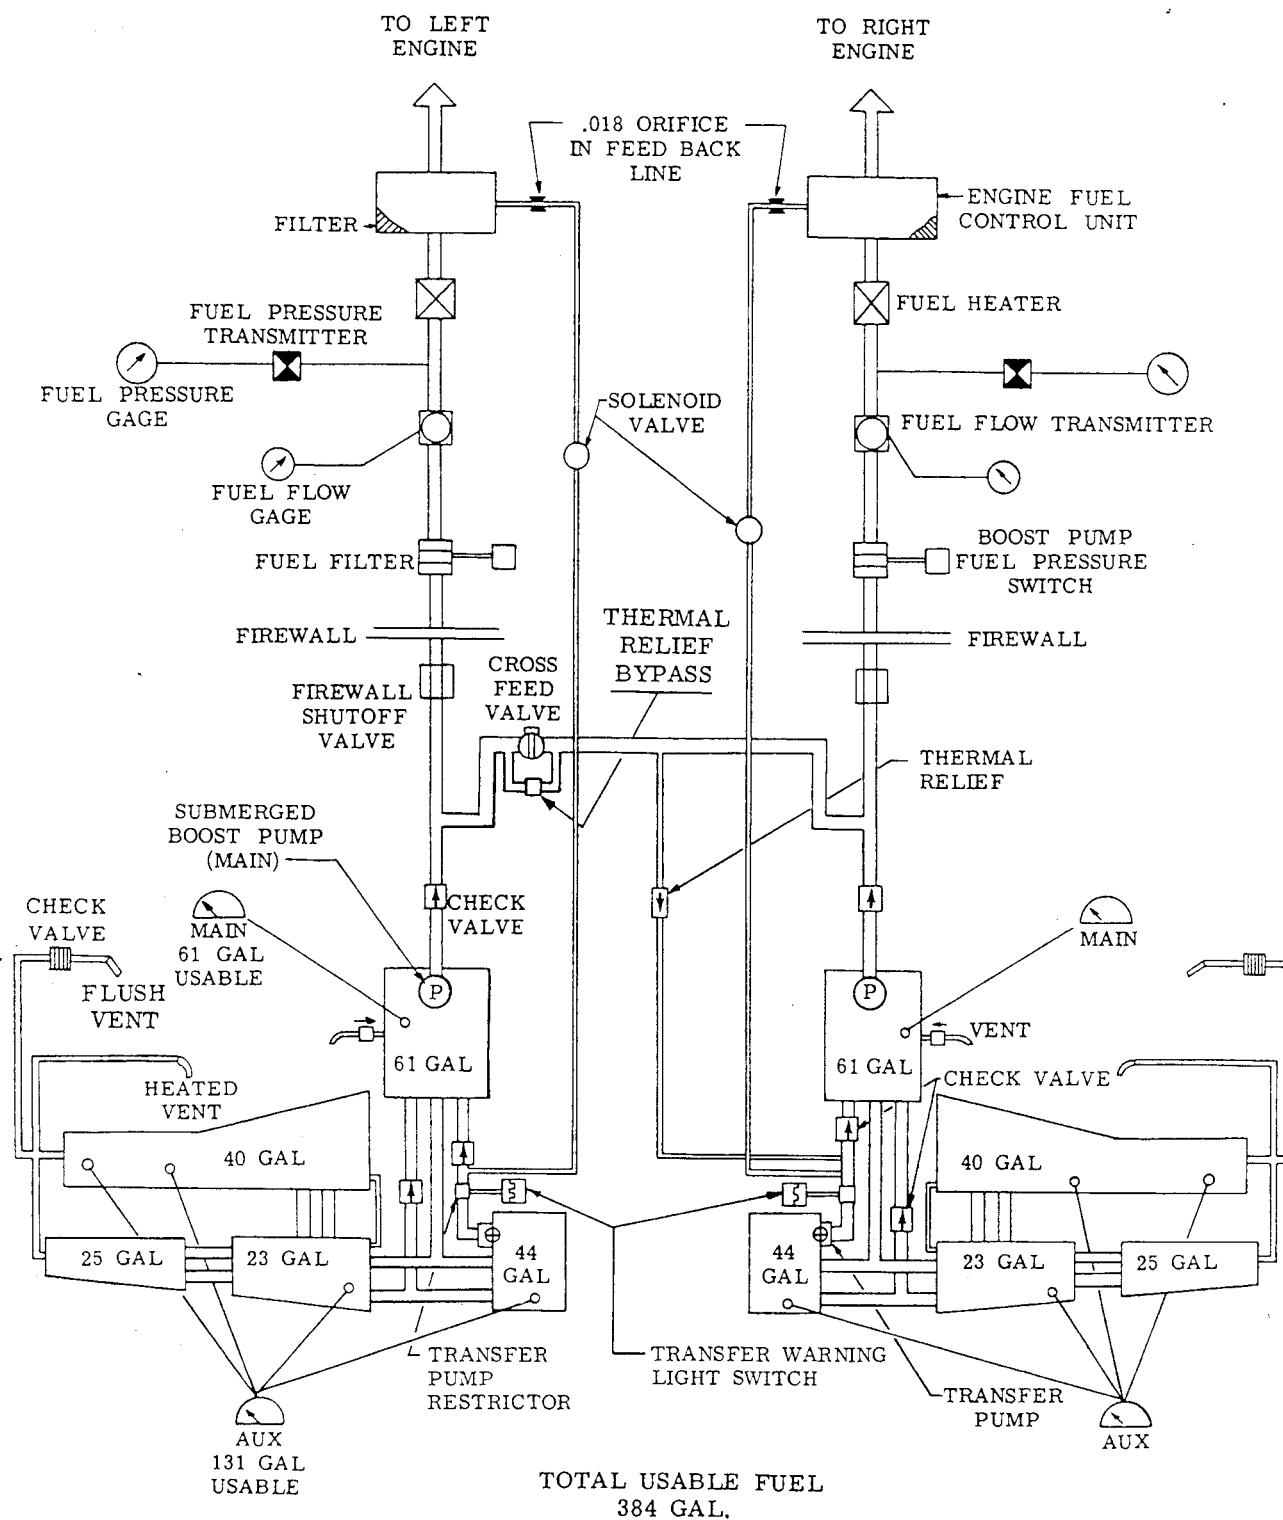
FUEL SYSTEM SCHEMATIC

If the transfer pump fails to operate during flight, gravity feed will take over its work. When the main tank level drops to approximately 3/8 full, the gravity feed port in the main tank opens and gravity flow from the wing tank starts. All wing fuel except 28 gallons from each wing will transfer during gravity feed. Whenever the left main tank supply drops to 10 gallons or less, fuel flow to the combustion heater shuts off.
